-----  
FIELD SUPPORT TECHNICAL BULLETINVolume: 7    Week: 2    Page: 1 of 1  
-----

FIELD SUPPORT TECHNICAL BULLETIN

Volume: 7    Week: 3    Page: 1 of 5

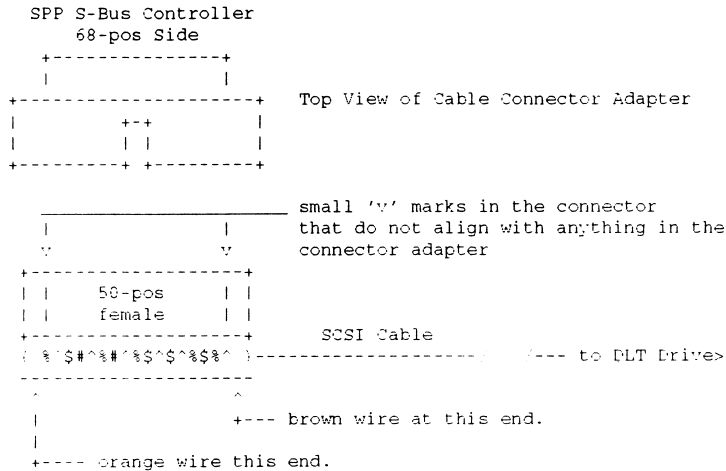
Unless care is taken, it is possible to connect one end of the SCSI cable incorrectly in the S\_BUS controller connector adapter, which results in device failures during boot.

The following drawing is provided to help eliminate these types of errors:-

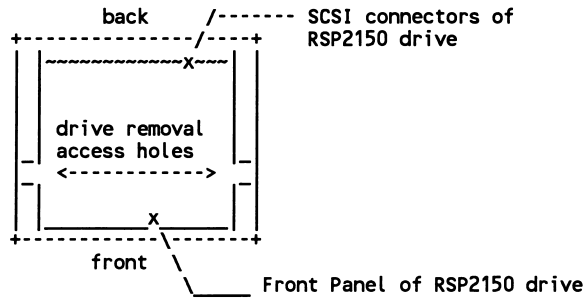
Shipping Container Plan View

In an attempt to reduce the shipping damage to Metrum RSP-2150 drives, a new shipping container has been introduced.

When shipping a drive in this new container please ensure that the RSP-2150 front panel is placed towards the front of the case.
