C3800 Troubleshooting Refresher Course

C3800

**Troubleshooting
Refresher
Course**

CONVEX Education Center

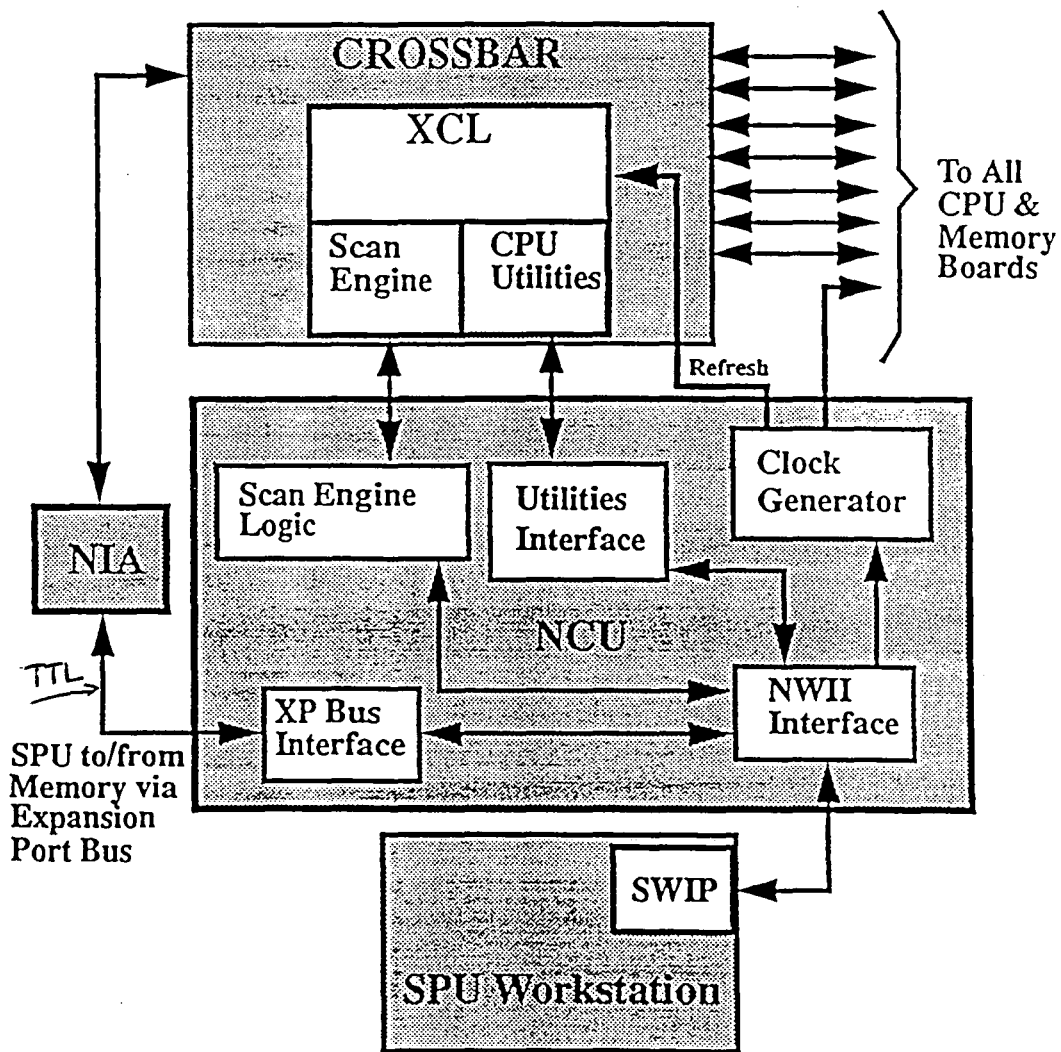
Figure 2-1

NCU Subsystems/Interfaces

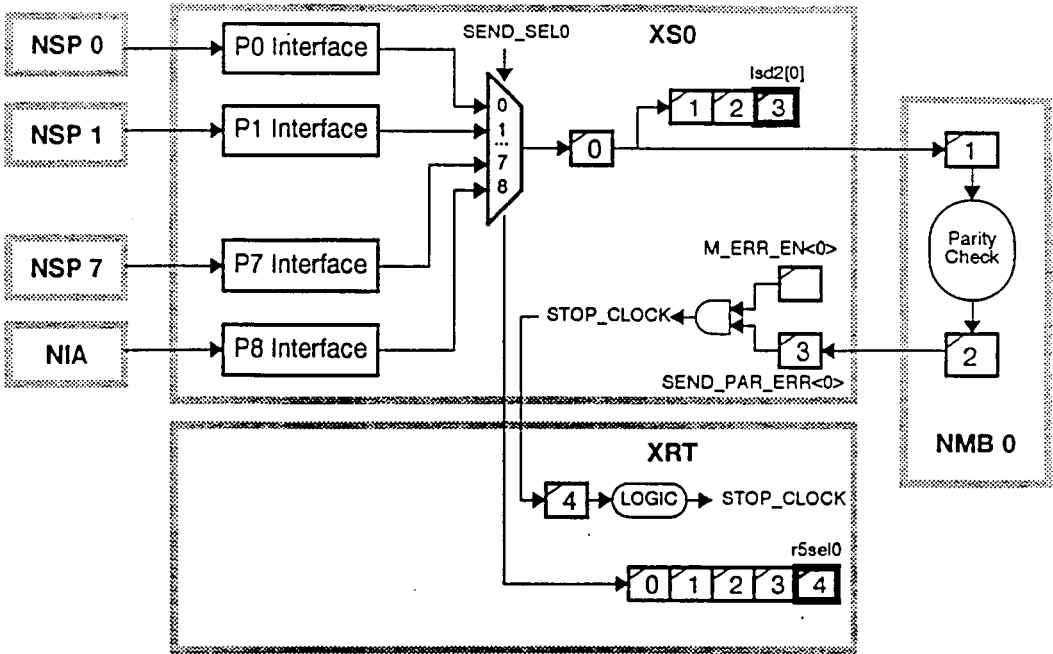
Figure 3-4
 Send Parity Error Capture

Crossbar Register

xs1e:wr_data_1sd2[m]
 xs1e:wr_par_1sd2[m]
 xs0e:addr_1sd2[m]
 xs0e:cycle_1sd2[m]
 xs1e:wr_zone_1sd2[m]
 xs1e:ctl_par_1sd2[m]

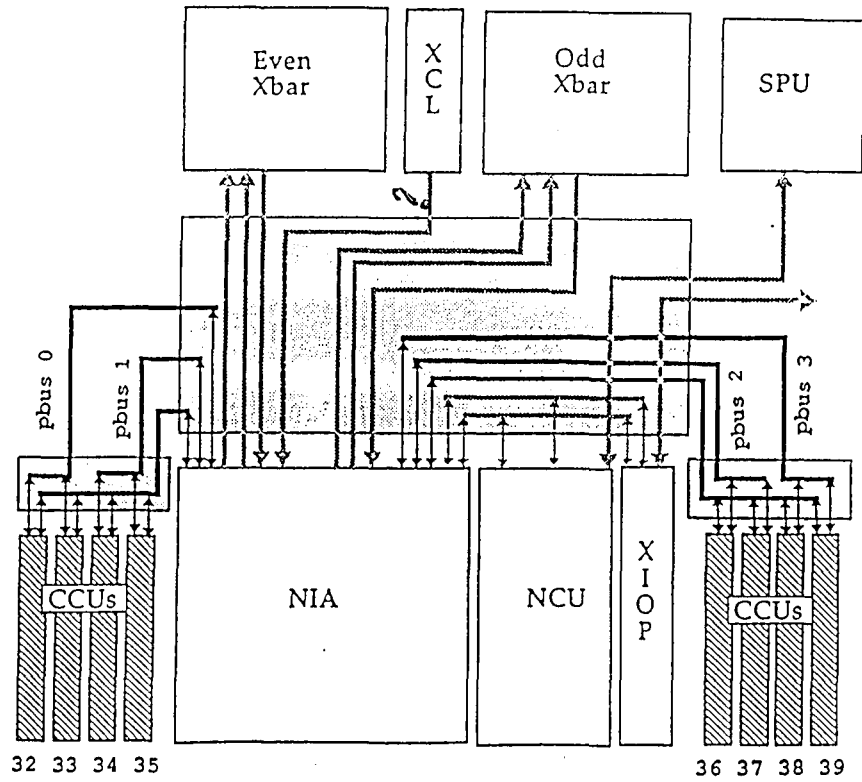
Figure 4-1

PBUS Interfaces

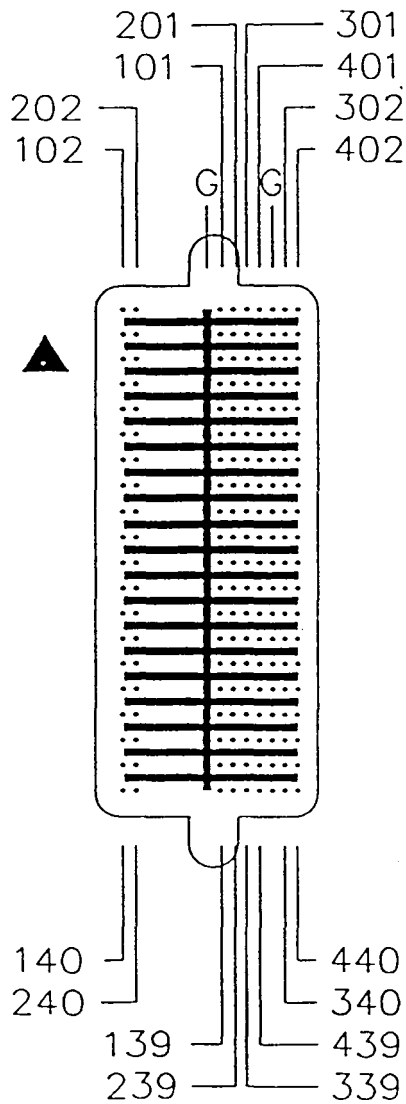
2.3 Xbar Augat Pin Outs (Bottom View).

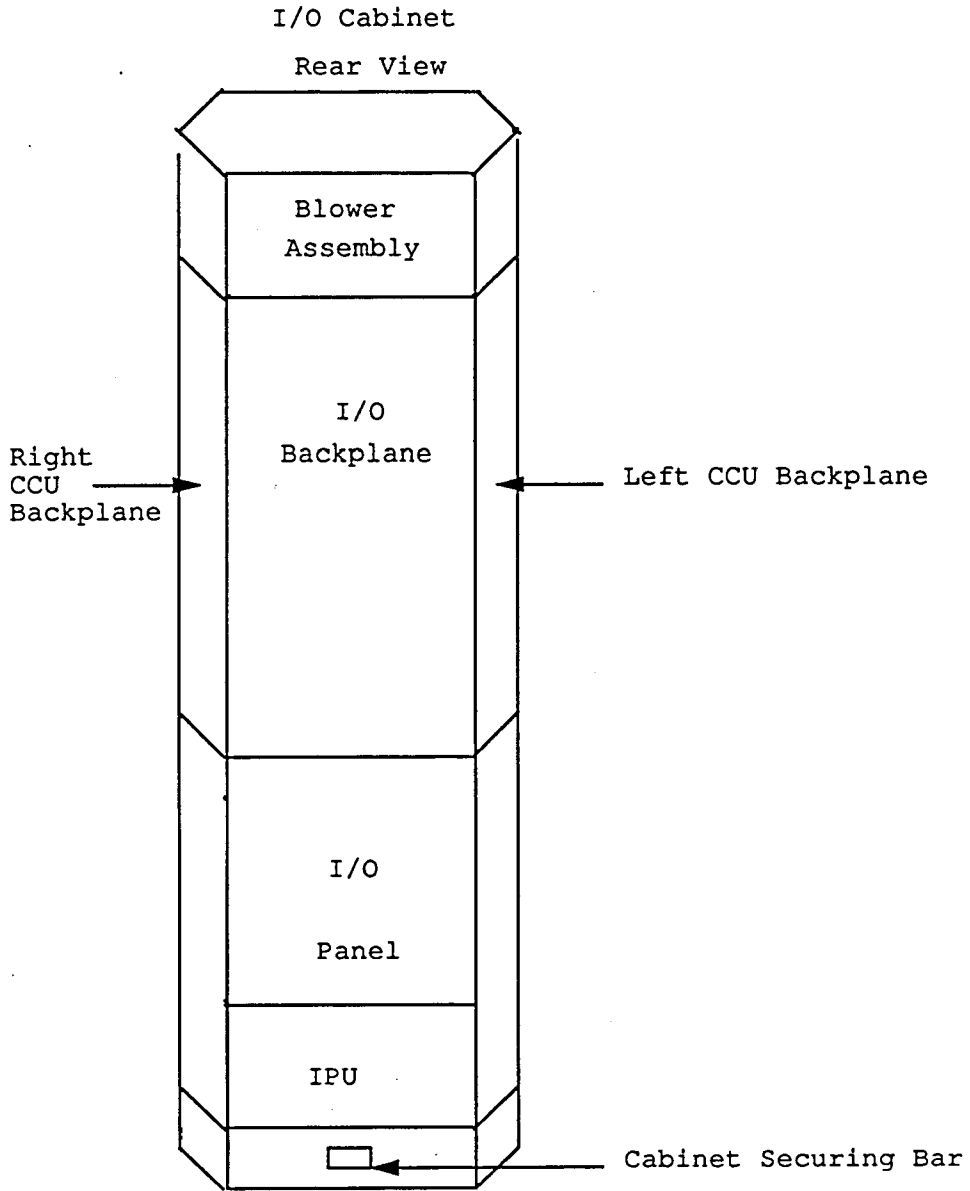
STANDARD IO PANEL CONFIGURATION
(Viewed from back of IO Bay)

DIFF. p2lp3lp4lp5 CCU39	VIOP p2yl p3yl p4yl p2xl p3xl p4xl CCU35
DIFF. p2lp3lp4lp5 CCU38	DIFF. p2lp3lp4lp5 CCU34
DIFF. p2lp3lp4lp5 CCU37	DIFF. p2lp3lp4lp5 CCU33
VIOP p2ylp3ylp4ylp2xlp3xlp4xl CCU36	DIFF. p2lp3lp4lp5 CCU32
