## FIELD SUPPORT TECHNICAL BULLETIN

## Contents of this issue:

1. Release of FMI-108 for SP1000/CD's
2. SPP Component Locations
3. C4600 Transformer Secondary Circuit Breakers

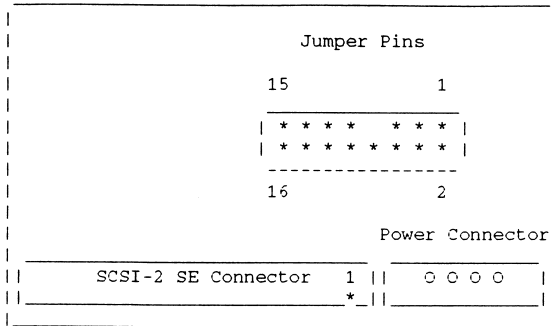
The new Conner model is CTD8000R-S, Convex PN 207-000041-200.

Jumper Configuration:

- Pins 15-16 = In (Termination Power on)
- Pins 13-14 = Out (No Connection)
- Pins 11-12 = In (Active Termination enabled)
- Pins 9-10 = In (Data Compression disabled)
- Pins 8-10 = Out (Power-On Self Test enabled)
- Pins 5-6, 3-4, 1-2 = SCSI ID bits, according to Table 1.
