**IBM** Maintenance  
Handbook

**IBM 3270 Information  
Display System**

## **Maintenance Handbook**

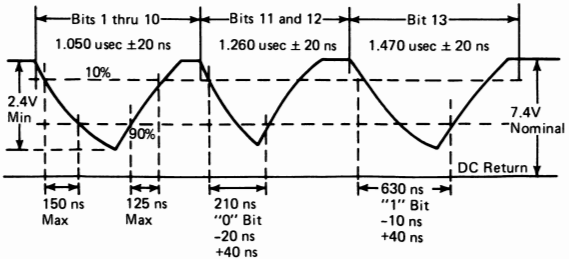
Bits on the coaxial cable center conductor appear as negative-going pulses. The center conductor of the coaxial cable, when measured at the control unit with reference to the outer conductor (shield), will be +7.4 nominal (+1.1 - 2.2) volts with no signal present and power on at each unit. For maximum coaxial cable length (2000 feet or 610 m) the signal from the control unit on the coaxial cable center conductor will appear at the device as follows:

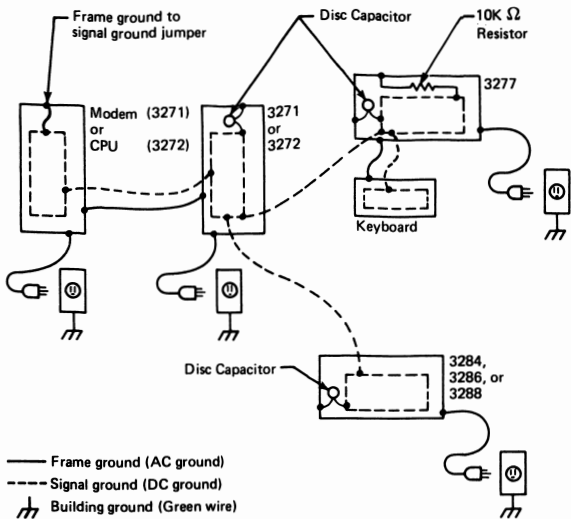
Figure 1-2. 3270 System Grounding

Signal ground and frame should be tied together only in the channel, external modem or modem cable. If these grounds are tied together at any other place, a ground loop condition can occur. The most common areas to find ground loops are in the keyboard (3277 ECA number 035 corrects this problem) and coaxial cable connections. Check for all ground loops while at the control unit by doing the following:

2. For devices, disconnect one coaxial cable at a time from the Control Unit and measure between the outer shield of the coaxial cable and frame ground of the control unit.

Device	Resistance
3277	7K to 10K ohms (min)
3284	Infinity (open circuit)
3286	Infinity (open circuit)
3288	Infinity (open circuit)

## MISSING GROUNDS (Fig. 1-2)

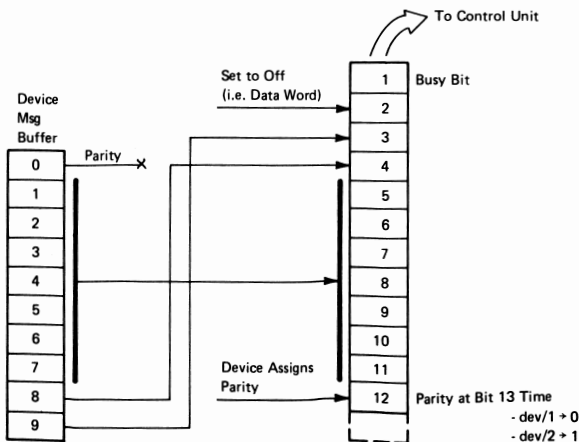
Figure 1-17. Device Buffer Transfer (Data Words) to Control Unit

## Device SERDES is a 12 Position Shift Register

## Message Buffer Bit Assignment (Figures 1-17 and 1-18)

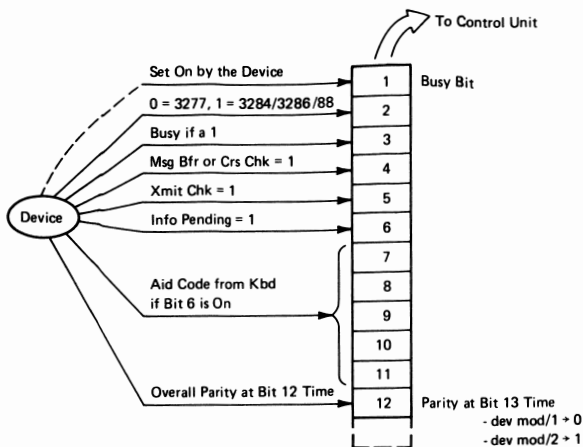
Figure 1-18. Status Word Sent by Device

## Device SERDES is a 12 Position Shift Register

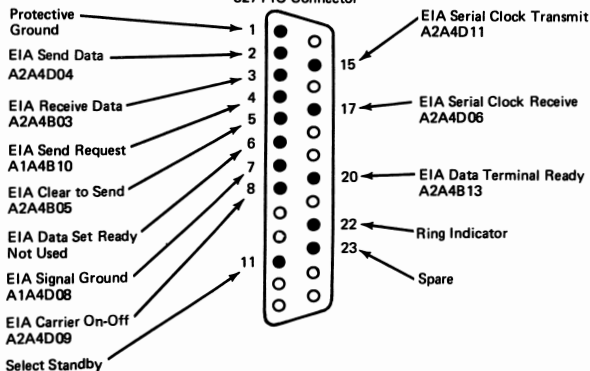
25-Pin Connector Mounted on 3271

EIA Line Name	EIA Pin No.	3271 Pin No.
Protective Ground	1	
Transmit Data	2	B2D02
Receive Data	3	B2M10
Request to Send	4	B2B02
Clear to Send	5	B2B09
Data Set Ready	6	Not Used
Signal Ground	7	B2D08
Carrier Detect	8	B2U04
Serial Clock Transmit	15	B2S08
Serial Clock Receive	17	B2M12
Data Terminal Ready	20	B2B13

*Note:* Signals from data set to 3271 measure +3V to +25V for up level and -3V to -25V for down level. Signals to data set from 3271 measure +3V to +8V for up level and -3V to -12V for down level.

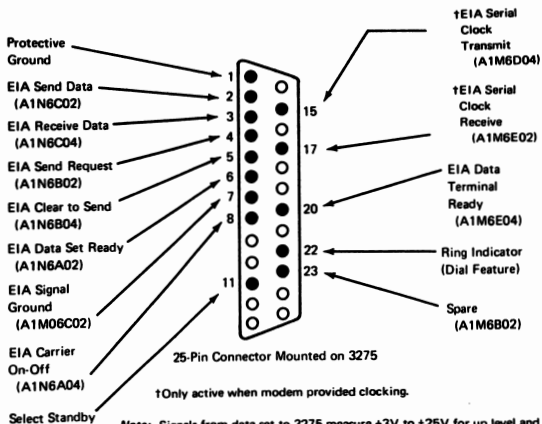
EIA Line Name	EIA Pin No.	3275 Leased Pin No.
Protective Ground	1	"Pigtail to frame ground from cable connector
Transmit Data	2	01B-M2D02
Receive Data	3	01B-M2M10
Request to Send	4	01B-M2B02
Clear to Send	5	01B-M2B09
Data Set Ready	6	Only used on Dial Feature
Signal Ground	7	01B-M2D08
Carrier Detect	8	01B-M2U04
Serial Clock Transmit	15	01B-M2S08
Serial Clock Receive	17	01B-M2M12
Data Terminal Ready	20	01B-M2B13
Ring Indicator	22	Only used on Dial Feature

**Note:** Signals from data set to 3275 measure +3V to +25V for up level and -3V to -25V for down level. Signals to data set for 3275 measure +3V to +8V for up level and -3V to -12V for down level. Protective ground pin 1 does not pick up ground from 3270. Ground is the cable shield and is clamped to the 3270.

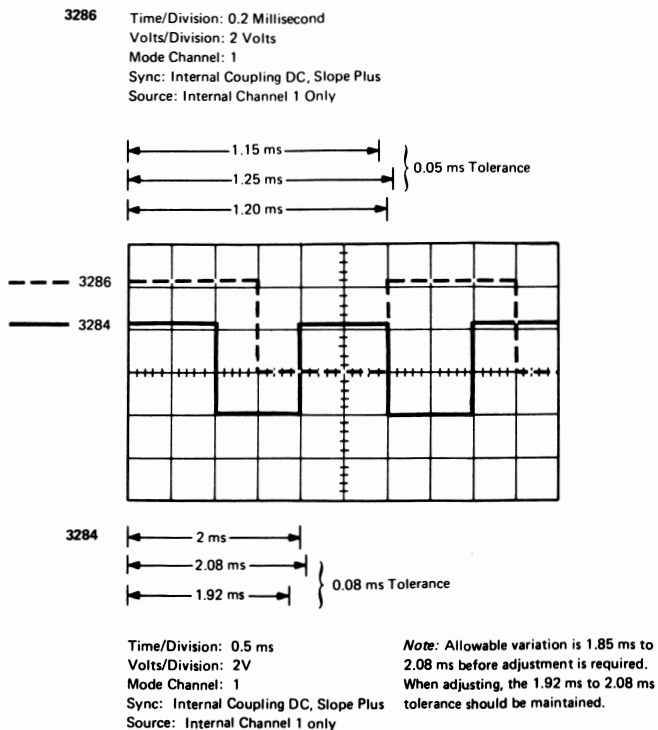
Figure 6-13 (Part 2 of 3). 3284/3286 Transducer-Adjustment Procedure

1. Sync on and look at the output of the reverse transducer at point A1B2-D12.
2. Loosen two mounting screws on the reverse feedback transducer mounting plate, and adjust eccentric to obtain proper trace **A** as the carriage moves in a reverse direction. Press mounting plate toward emitter wheel, and tighten mounting screws.
3. Remove the jumper used to disable high-speed return, and check that the carrier returns at high speed.
4. Proceed to procedure C, Print Carrier and Print Emitter Adjustment.

**A** Typical Speed Adjustment Trace

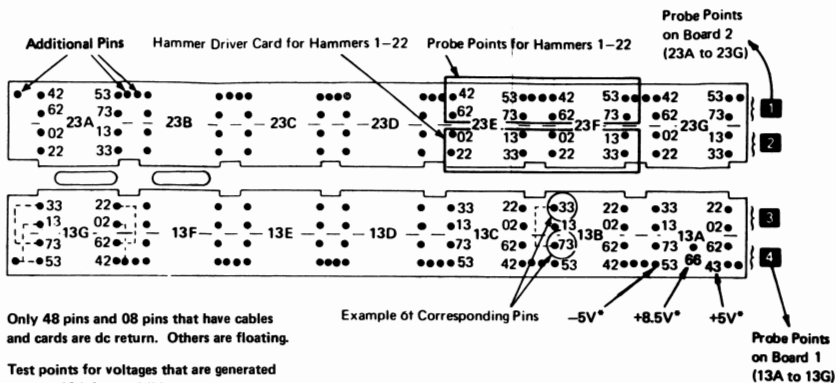
Figure 7-4. Printer Card Gate Layout

To determine a probe pin when given a signal pin, add 40 to the signal pin.

Example: Signal 13C06 - Probe 13C46.

Only 48 pins and 08 pins that have cables and cards are dc return. Others are floating.

Test points for voltages that are generated by card 13A from +24V.

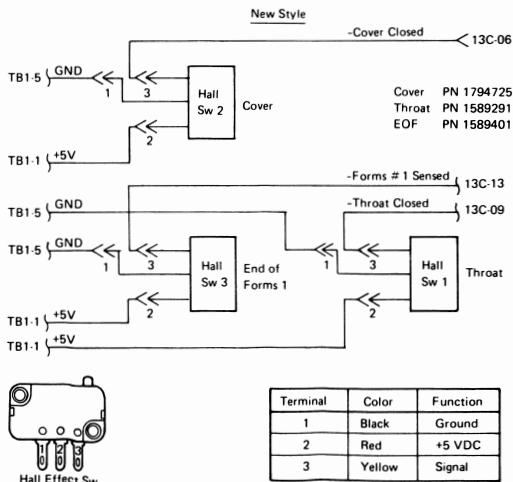
**Figure 7-13. Cover/End of Forms/Throat (Hall Effect) Switches**

*Note:* The old style and new style switches are not interchangeable.

Figure 7-13 illustrates the old and new style Hall Effect switches.

*Note:* The cover interlock switch should be checked on each service call to verify that the belt stops when the cover is open.

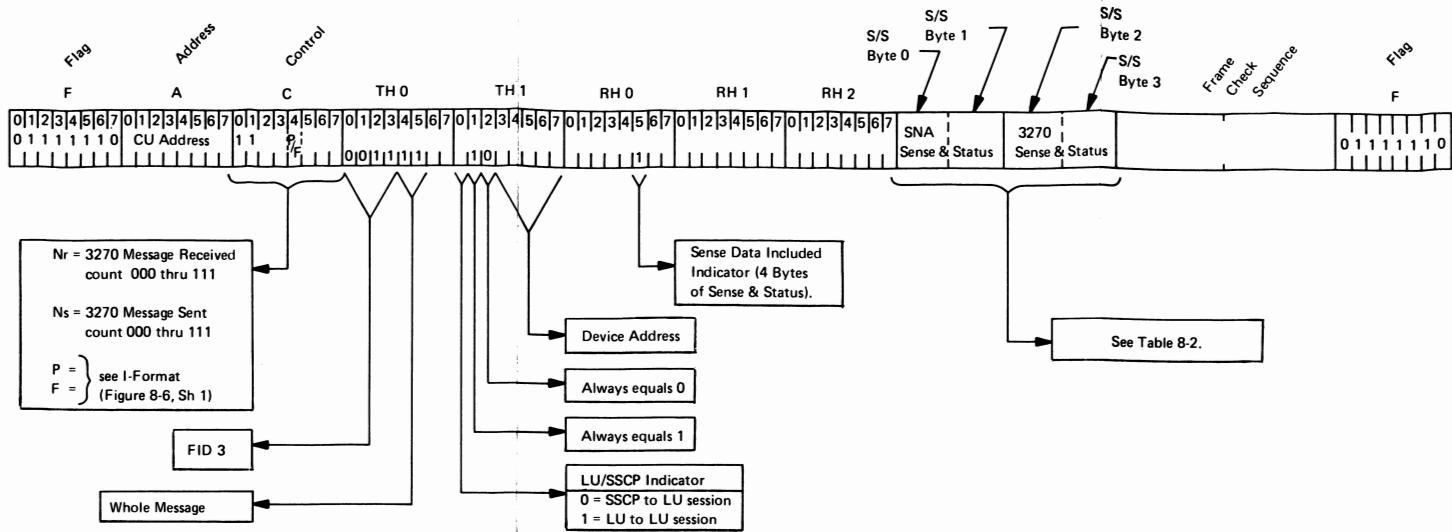
Figure 8-7. Sense/Status Message Format

Note: This chart is intended to show those bits that must be on for a S/S message. For all other bits, see I-Format, Figure 8-6, Sheets 1 and 2.

Sense/Status Message Format (SDLC) 8-14  
 Sequence Latches 1-21  
 Sequence/Response Diagrams (Remote BSC):  
   Control-Type Commands (Fig. 1-45) 1-76  
   Example of Maintained Connection (Fig. 1-49) 1-84  
   Poll Sequences, General and Specific (Fig. 1-42) 1-70  
   Read-Type Commands (Fig. 1-43, 1-46) 1-72,1-78  
   Selection Addressing Sequence (Fig. 1-44) 1-74  
   Status Message Transmission with Dial Feature (Fig. 1-50) 1-86  
   TCU - Initiated Transmission (Fig. 1-48) 1-82  
   3275 Initiated Transmission (Fig. 1-47) 1-80  
   Write - Type Commands (Fig. 1-45) 1-76  
 Sequence/Response Diagram (SDLC):  
   Online and Offline (Fig. 8-17) 8-24  
   Read Type Command (Fig. 8-18) 8-25  
   Write Type Command (Fig. 8-19) 8-26  
 Serdes, Device 1-35,1-36  
 Serial Clock Transmit (SCT) Test Point 2-20  
 Service Aids:  
   3270 1-15  
   3271 2-20  
   3272 3-16  
   3275 4-30  
   3277 5-21  
   3284/86 6-25

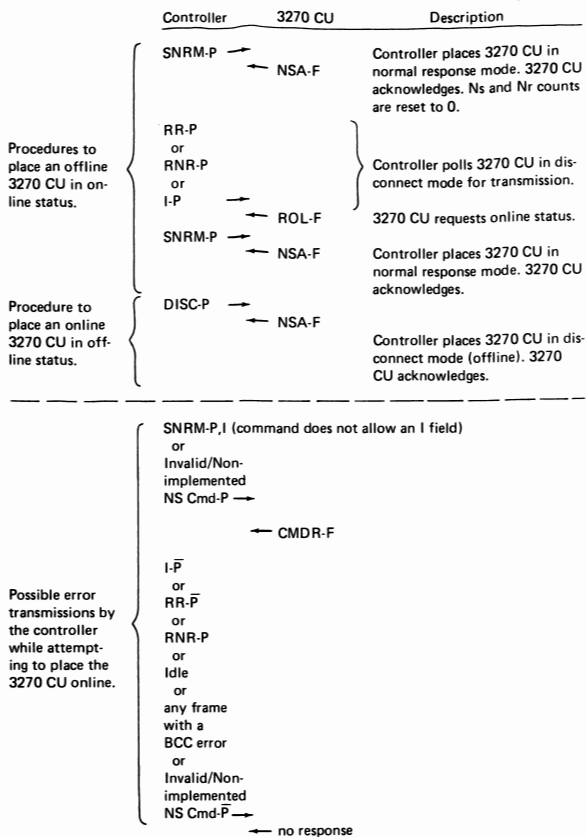
Figure 8-17. Online and Offline Sequence/Response Diagram

Note: Only SDLC bytes that are significant for the sequence being illustrated are shown in the diagram.

P/F=poll/final bit

dash (-) above a letter = not set to 1.

MLTG Updates (3284/86)	6-43
Modem or Line Scoping Procedure	2-21
Motor Control Card Jumpering	6-41
Multiplexer Shift Register Bits	1-35
New Line/End of Message Orders Printing as 5's and 9's	6-42
Non-Sequenced Message Format (SDLC)	8-16
Online and Offline Sequence/Response Diagram (SDLC) (Fig. 8-17)	8-24
Order Codes and Buffer Orders	1-49
Parts Catalog Corrections and Additions 3284/86:	
Forms Tractor RPO	6-44
Standard	6-37
Variable Margin RPO	6-44
Platen Assembly (3288)	7-17
Platen/Ribbon Shield Assemblies (3288)	7-27
Poll, General and Specific	1-43
Poll Sequences, General and Specific:	
Addresses	1-58
Sequence/Response Diagram	1-72
Power Supplies, Voltages	2-23,6-34
Power Supply Ripple (Fig. 1-1)	1-6
Print Belt Motor Drive Pulse (3288)	7-29
Print Head Plug Description (3288)	7-13
Printer Cover Window Hazard	6-37
Printer Printed Circuit Board Damage	6-37
Printer Status Word (Fig. 1-9)	1-29
Printer Status Word Detected on 3271 Control Unit	1-26
